*Airfield Damage Repair Modernization Program*

## **AM2 Brickwork Pattern Evaluation with Refurbished Matting**

Lyan Garcia, Timothy W. Rushing, and Jeb S. Tingle

August 2015

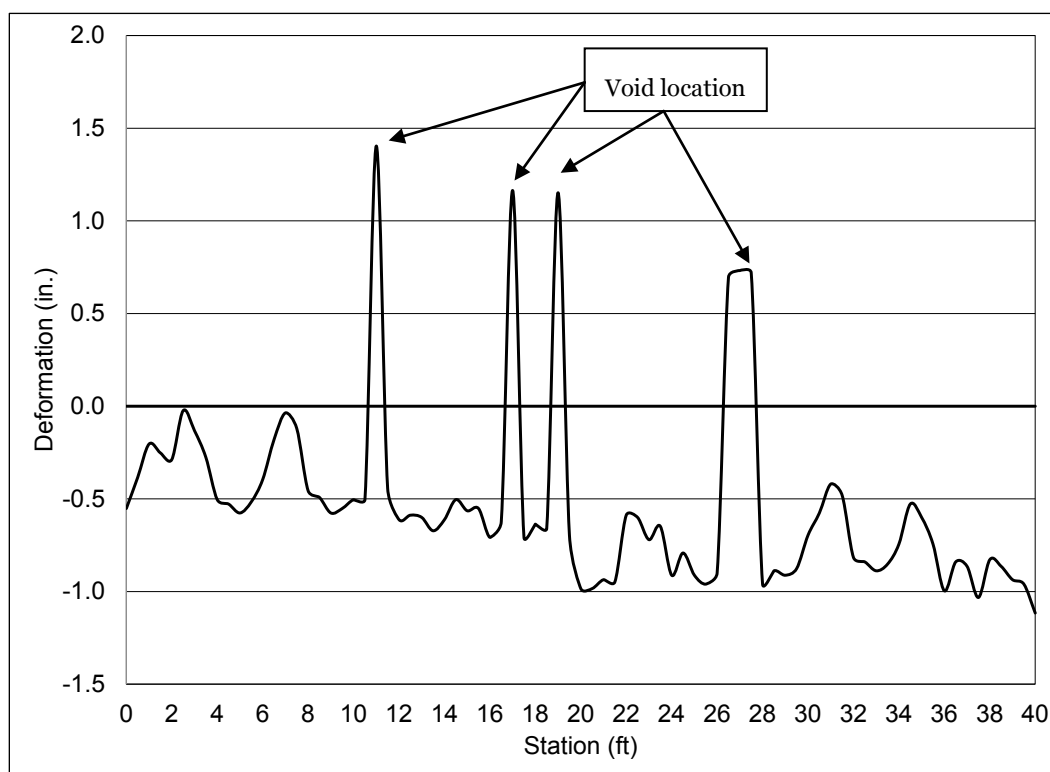
Plots of the centerline profile data on the subgrade and mat surface, as determined from robotic total station recordings, are shown in Figures 45 and 46, respectively. In Figure 45, peaks observed at stations 11, 17, 19, and 27 were the locations of voids V1-A, V-F, V1-B, and V1-C, respectively, along the centerline. The positive values are a result of rearrangement of material into the excavated void area during traffic. The initial depth of the voids was 2 in., but the depth decreased throughout traffic with the rearrangement of particles. These were ignored when determining the maximum roughness value. Plots of the average cross-section elevation data, collected along lines A1, A2, and A3, are shown in Figures 47 through 49.

Figure 45. Subgrade centerline profile of the F-15E-V item after 322 passes.

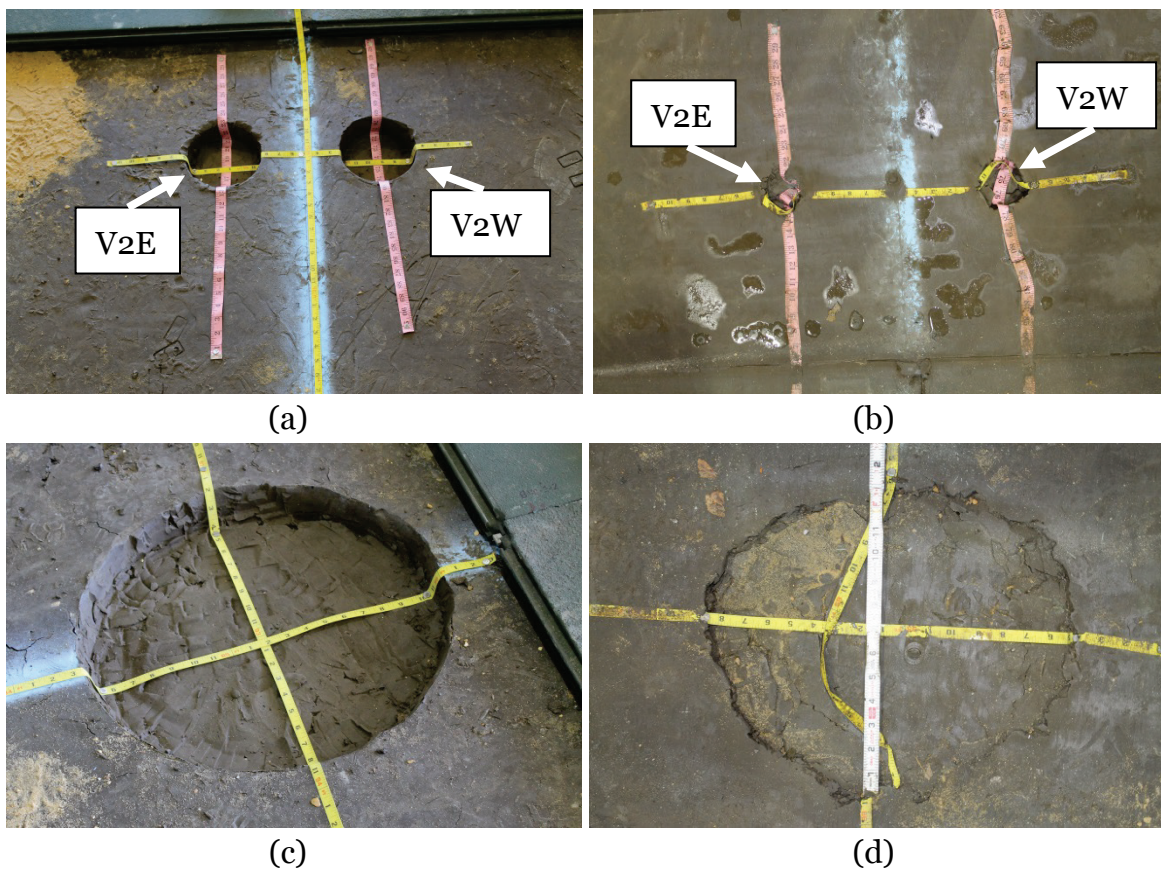
In an attempt to monitor the progression of deformation where voids were excavated, observation holes were drilled in several panels at the positions where voids were located (with the exception of void V-F). Void V-F was excavated to determine the effect on the performance and strain measurements at an F-joint. Figure 50 shows the variation of the depth of the voids underneath the mat during traffic. After removing the mats, the voids were visually inspected to determine the extent of movement of material in those specific areas. It was observed that the diameter of the voids reduced and that material filled in the excavated areas, making the center of the voids nearly level and uniform with the subgrade surface. Figure 51 shows pretest and posttest photos of voids V2W, V2E and V1-C.

Figure 51. V2W, V2E (a) pretest and (b) posttest and V1-C (c) pretest and (d) posttest.

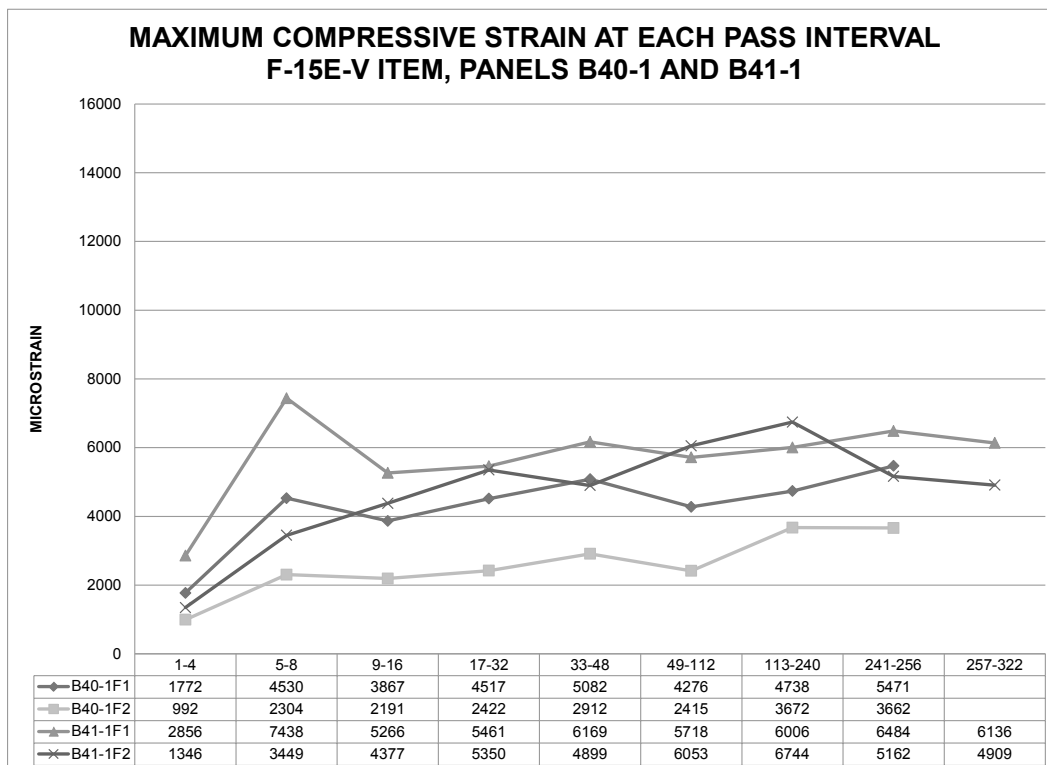
Failure of the upper underlap rail of panel B40-1 at 322 passes is apparent from the disappearance of data in Figures 60 and 61 during pass interval 257-322. Gauges B40-1F1 and B40-1F2 both malfunctioned and recorded unusable data after the rail broke. Gauge B37-2F2 was damaged during mat installation; therefore, any data recorded by this gauge was disregarded and not reported. High compressive strains were recorded throughout at the test at B37-2F1, which was located above void V-F. Tensile and compressive strains at refurbished Panel B41-2 (located between the largest voids) on average appeared to be higher than at other locations. Its connecting panel (B40-2), which was new, recorded relatively high tensile strains, but very low compressive strains (on average) at the lower overlap rail. The remaining data show that a clear trend is not observed that links void size the panel strain measurements.

Figure 61. Max compressive strain at F-15E-V item panels B40-1 and B41-1.

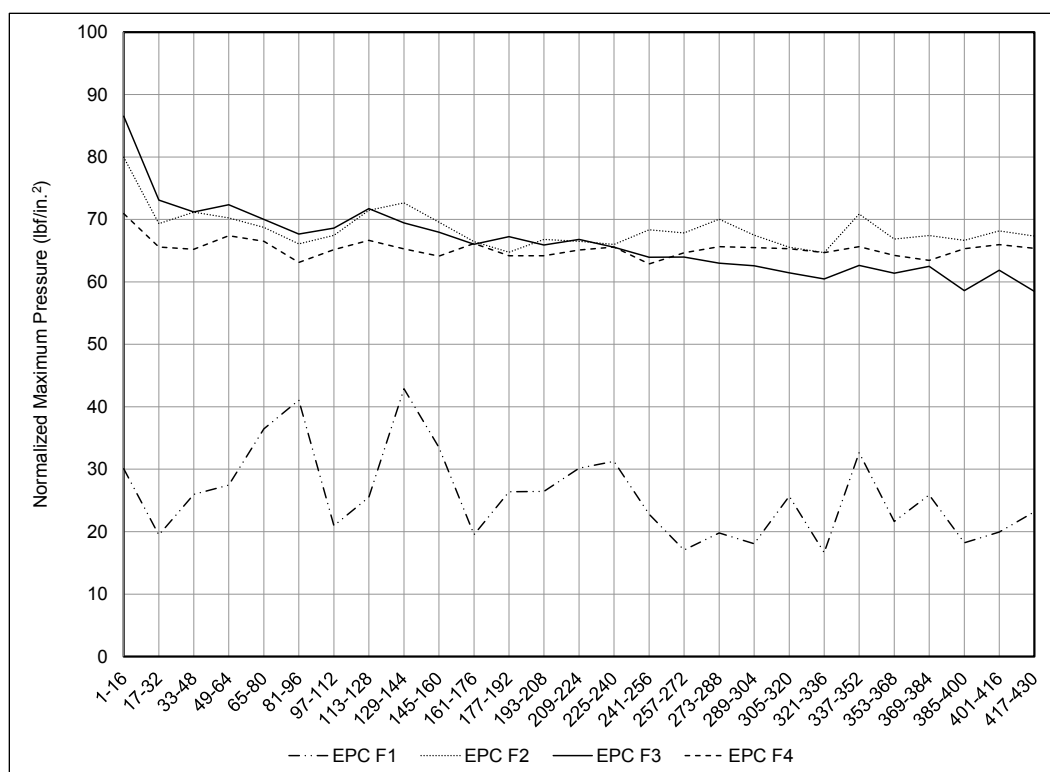
Figure 93. Summary of normalized maximum pressure for the F-15E item.

Figures 93 and 94 are graphical summaries of the maximum normalized pressure values measured throughout traffic for the F-15E and C-17 items, respectively. These summarized data have been normalized to only show the influence of the load cart on the subgrade by removing the effects of soil overburden pressure. Table 19 summarizes the range of maximum normalized pressure values for each of the EPCs throughout the test.

The EPC data obtained during trafficking show the stresses measured in the subgrade 3 in. below the surface. Maximum pressure ranges for each instrument are reported in Figure 93 and Table 19. As expected, pressure values measured at the offset location were on average at least 40 lbf/in.<sup>2</sup> lower than pressure measured under the centerline. Similar maximum pressure values measured by instruments under the centerline are good indicators of the individual, connected panels working and moving as a uniform system. Rushing and Tingle (2007) installed EPCs at depths of 12 in., 30 in., and 54 in. As expected, maximum pressure values reported by the authors were lower than those measured in this test at 3 in. below the surface, with maximum pressure measured at 12 in. below the surface being in the range of about 35 lbf/in.<sup>2</sup> to 45 lbf/in.<sup>2</sup>.

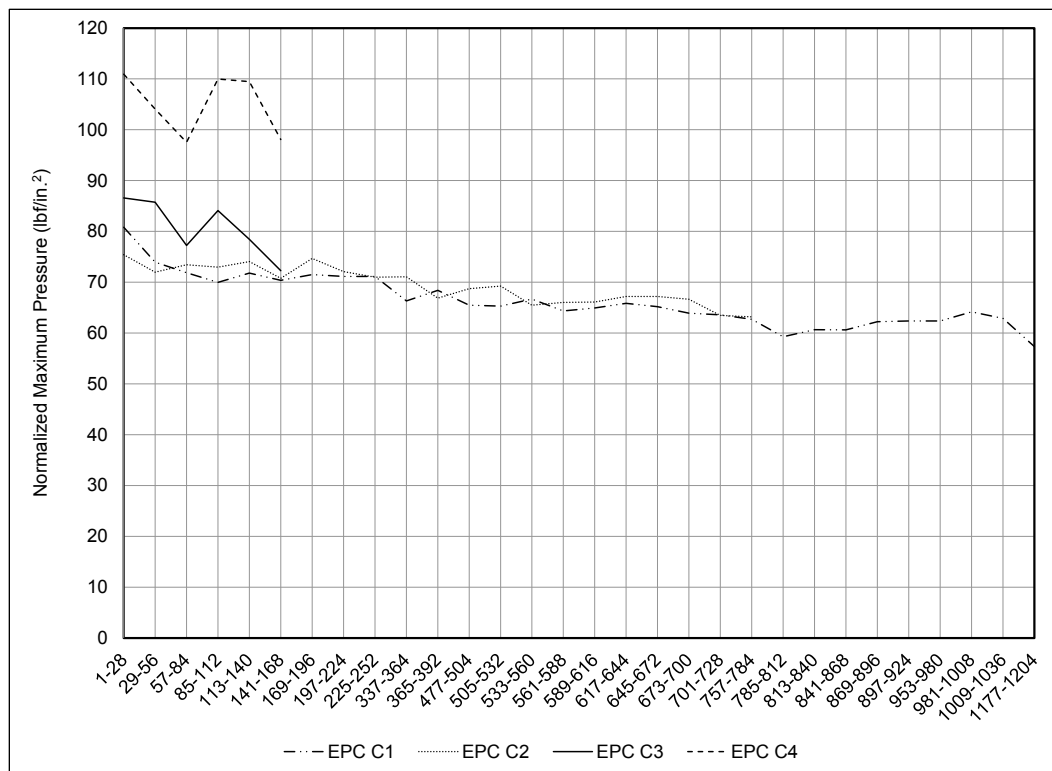
Figure 94. Summary of normalized maximum pressure for the C-17 item.

instrument are reported in Figure 94 and Table 19. Similar pressure was measured by EPC C1 3 ft offset from the centerline and EPCs C2 and C3 under the centerline. This makes sense, since the load cart centers at the location of EPC C1 during the first few passes of each traffic interval. The multiple-wheel gear is also able to spread the load over an area large enough that will cause a similar response at instruments just 3 ft from the centerline. This information gives further evidence of the ability of the mat to work as a uniform system rather than individual panels performing separately. EPC C4 under the center of a panel recorded much higher pressure responses throughout traffic when compared to the other EPCs. This was unexpected, since Rushing and Tingle (2007) reported similar values for EPCs placed at 12 in. both under joints and under the center of panels. Average pressure at the 12-in.-depth was 50 lbf/in.<sup>2</sup>, a difference of at least 50 lbf/in.<sup>2</sup> to the pressure measured at 3 in. The opinion of the authors of this report is that EPC C4 reported values that are not dependable, which may be a result of improper placement or discrepancies with the gauge itself. Evidence that supports this is the malfunction of EPC C4 after 168 passes.

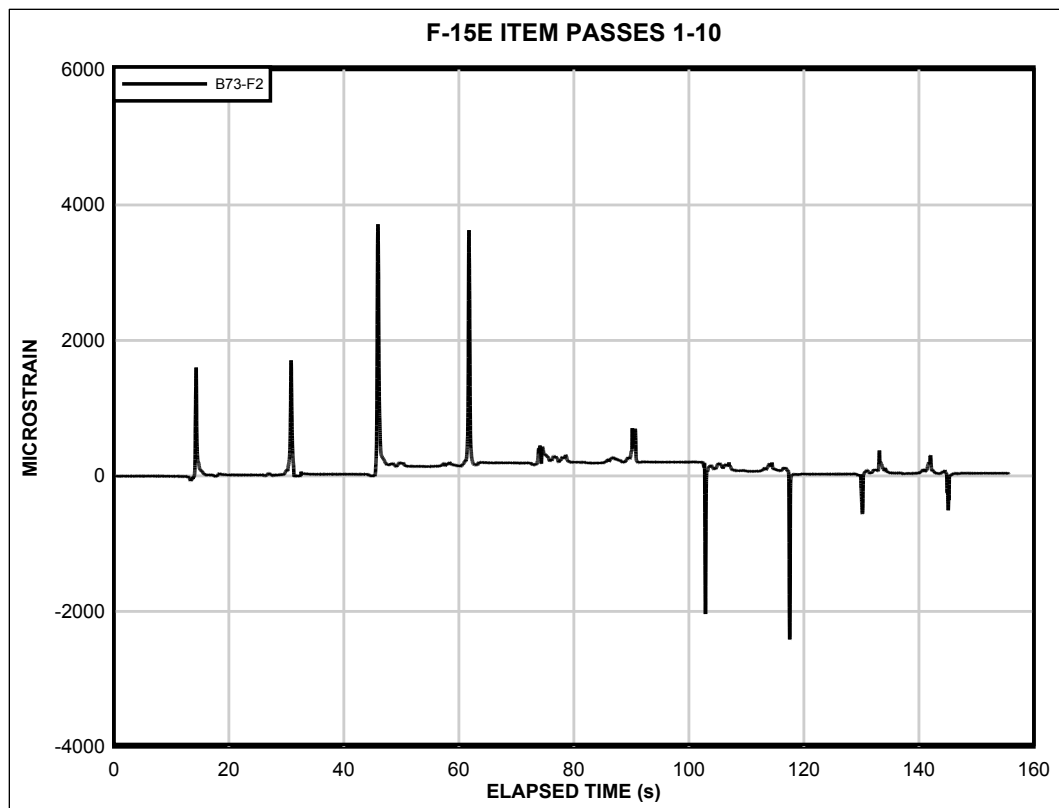
Figure 95. Strain gauge data for F-15E item, SG B73-F2, passes 1-10.

Example plots of the strain gauge raw data for the F-15E and C-17 items are shown in Figures 95 and 96, respectively. Figure 95 represents the response from the first ten passes of F-15E traffic from a gauge installed on the upper underlap of Panel B73. Each of the positive peaks represents tensile strains, and the negative peaks represent compressive strains. Each of the ten passes can be associated with a measured peak. Since the distributed traffic pattern began on the east side of the gauge location, the gauge did not measure significant tensile strains during the first two passes. The data set validates that the load moved to the west side of the joint on pass seven, where there is a shift to compressive strains that decrease in magnitude as the load moves further from the gauge. The changing magnitude of the peaks was caused by the wander pattern used to simulate a normal distribution of traffic over the test section. The higher peaks indicate that the load cart was located adjacent to the strain gauge.

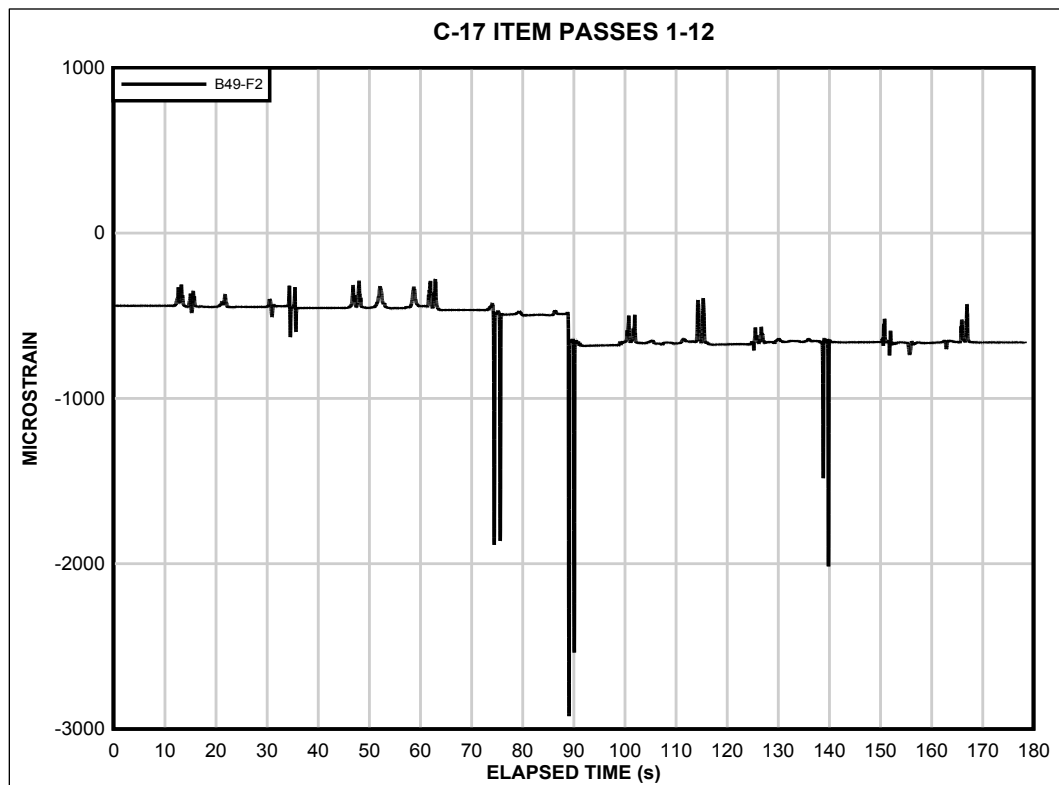
Figure 96. Strain gauge data for C-17 item, SG B49-F1, passes 1-12.

Figure 96 represents raw data collected for the first 12 passes of the 6-wheeled C-17 load cart from a strain gauge mounted on the lower overlap rail of Panel B49. Each pass is indicated by two large peaks and one small peak, representing the two main axles of the C-17 and the drive axle of the scraper engine used to pull the simulator, respectively. Since the distributed traffic pattern began on the east side of the gauge location, the gauge did not measure significant tensile strains during the first four passes. The data set validates that the load moved closer the joint on pass six, where there is a baseline shift indicating permanent deformation and large compressive strains. The magnitudes of the peaks when the load is on the west are observed to be higher, which is expected, since the gauge was mounted on a panel west of the centerline. The changing magnitude of the peaks is an indicator of the wander pattern associated with the load cart; however, the pattern is not as obvious when compared to that of the F-15E load cart, since the multiple-wheel C-17 simulator distributes the load over a larger area.

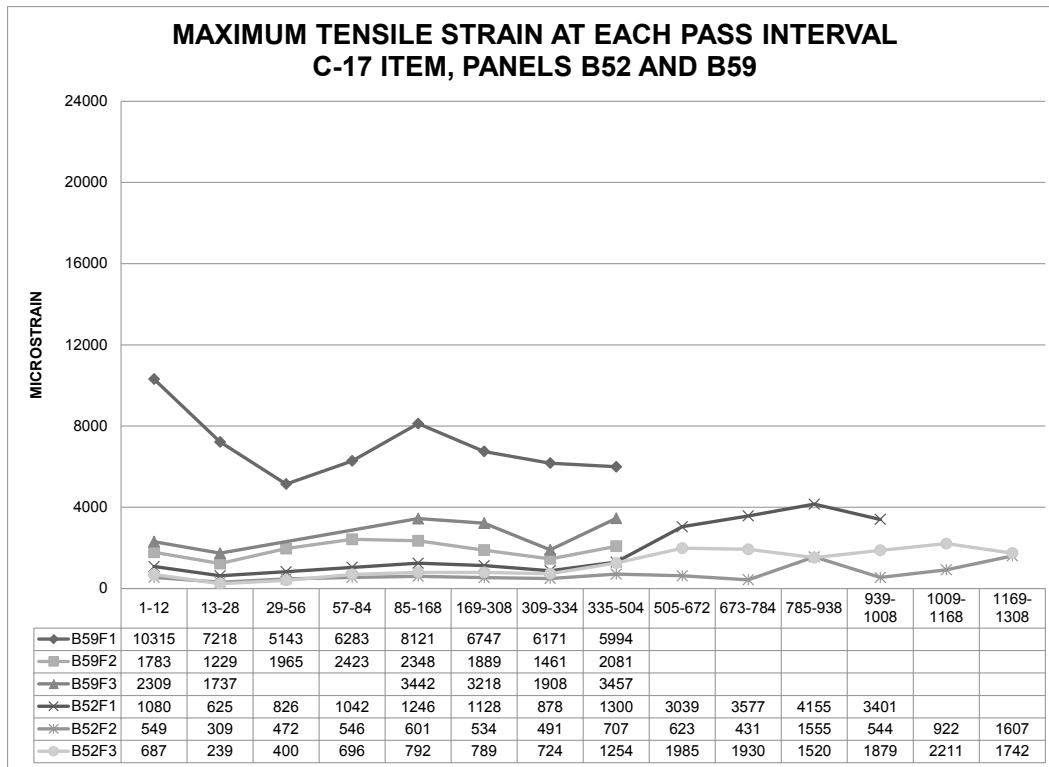
Figure 107. Max tensile strain at C-17 item panels B52 and B59.

For the C-17 item, Figures 107 and 108 show that gauges B59-F1, -F2, and -F3 all failed to return usable data between 505 and 672 passes. Visual observations reported failure of Panel B59 at 784 passes; however, the strain gauge data may be an indicator that failure at panel B59 occurred earlier than noted, or that high strains may have destroyed the gauges prior to complete breakage of the upper underlap rail. The same can be observed for panels B71 and B48. Failure of the lower overlap rail of B71 was noted when the panel was removed from the subgrade surface. The strain data show that B71-F1 malfunctioned during pass interval 335-504, and B71-F2 eventually malfunctioned during pass interval 1,009-1,168. The rail may have slowly cracked until it broke completely after 1,009 passes, or high strains measured at B71-F1 may have destroyed the gauge prior to actual breakage of the rail. Panel B48 was noted to have failed at 1,308 passes when the upper underlap rail broke, but strain data (Figures 105 and 106) indicate gauge failure before visual observations. Most likely, the gauge failures are directly linked to mat breakage.

Instrumented panels with rail failures were B59, B71, and B48. For each of these panels, breakage of each rail was noted after strain gauges were reported to have malfunctioned. The data suggests that either 1) the rails failed before visual observations of the surface could confirm mat breakage, or 2) high strains may have destroyed the gauges prior to complete breakage. Regardless, it is evident from the strain data that compressive strains in B59, B71, and B48 were larger than in other instrumented panels, which is useful for linking some value of compressive strain to crack initiation at the rails. A summary of the strain measured throughout the test for each gauge is reported in Figures 113 and 114. There appeared to be no trend as to whether strains were higher in refurbished panels or in new panels.

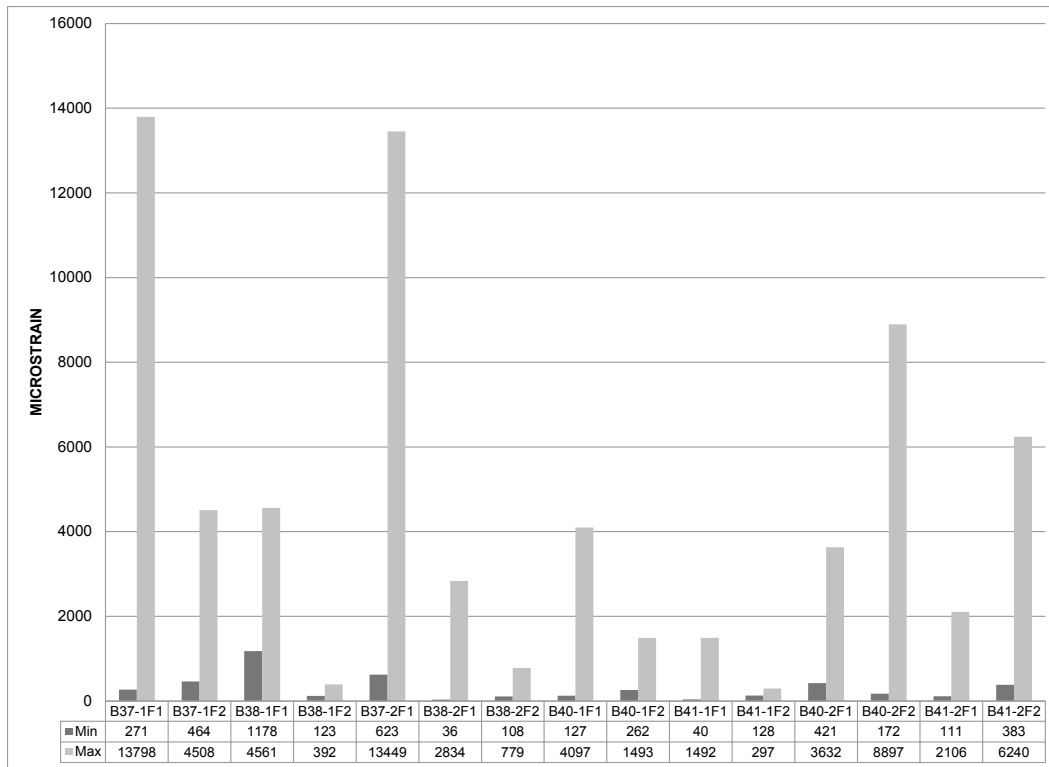
Figure 109. Summary of maximum tensile strain measured in F-15E-V item.

Analysis of the data from this test showed that the gauges performed as designed, and the measured strains appeared to be reasonable. Compressive strains appeared to be greater than tensile strains and controlled the failure of the rail at panel B40-1. The gauge data were able to validate the pass number at which the panel failed by sorting through the data and counting the pass where malfunction was evident. Compressive strains increased throughout traffic and were elevated before failure of the gauges occurred. A summary of the maximum strain measured in the F-15E-V item is reported in Figures 109 and 110. Compressive and tensile strains measured by gauge B37-2F1 reached maximums that exceeded values reported for most other panels. This is likely associated with the existence of void V-F beneath the joint of B37-2 and B38-2. There appeared to be no pattern as to whether strains were higher in refurbished panels or in new panels, even though damage was more prevalent in refurbished matting. Other than panel B37-2, a clear trend that linked strain measurements to void sizes near instrumented panels was not observed throughout the test item. An identical test is planned with an array of panels that are all new, in addition to tests with alternate pattern arrangements other than the brickwork pattern. Once all data have been collected, an in-depth analysis of the strain behavior for the different patterns will be conducted.

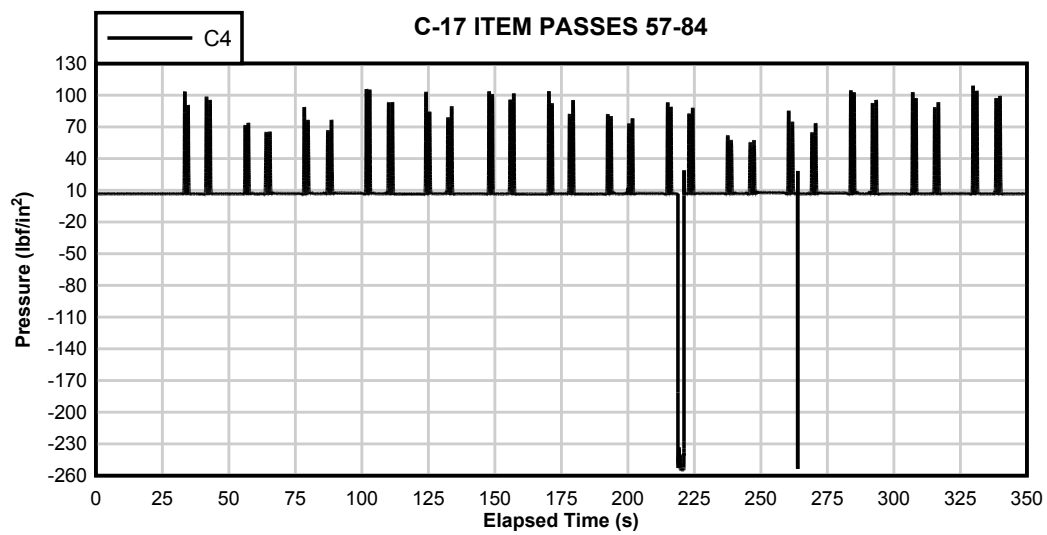
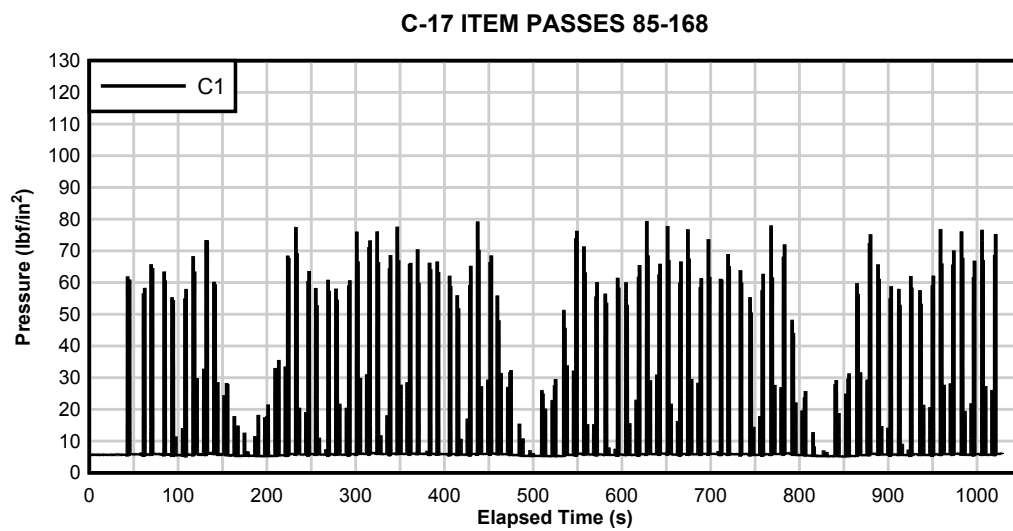
Note: C4 over-ranged in two instances.

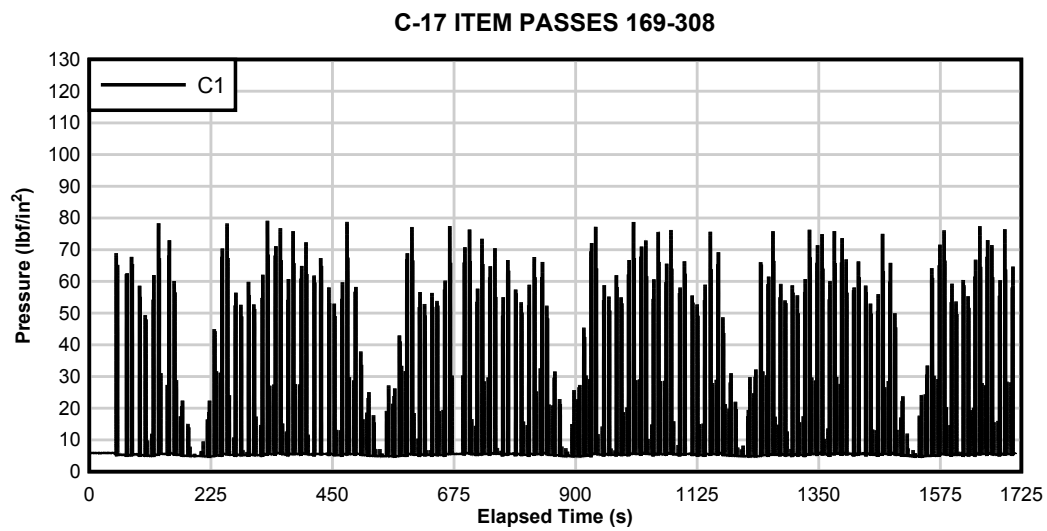
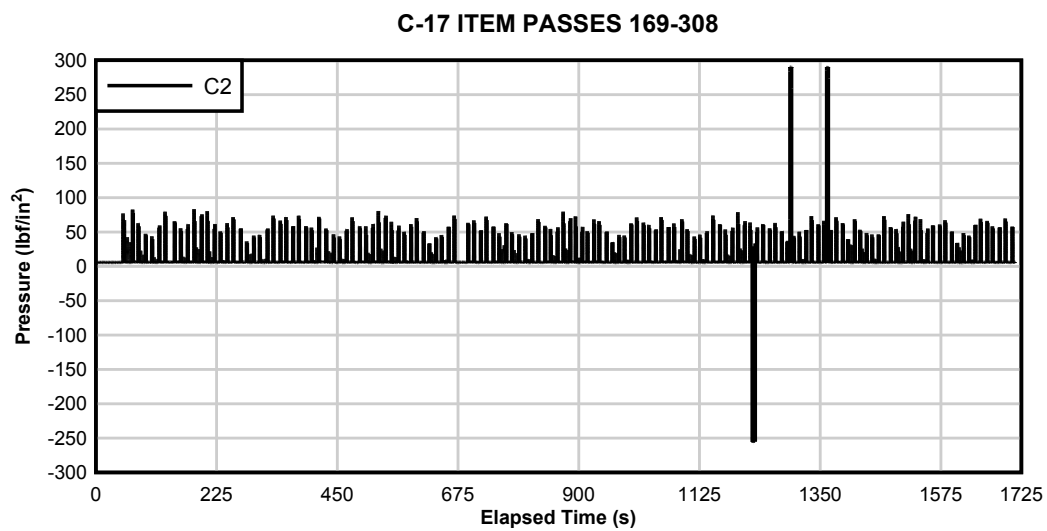
Note: C2 over-ranging in three instances. This data was not reported

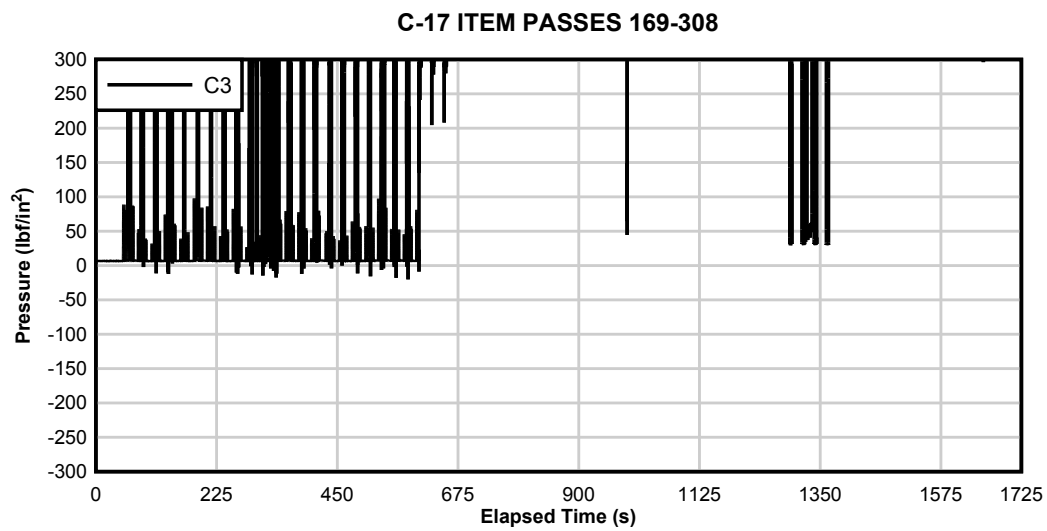
Note: C3 malfunctioned. Did not report usable data after pass 168.

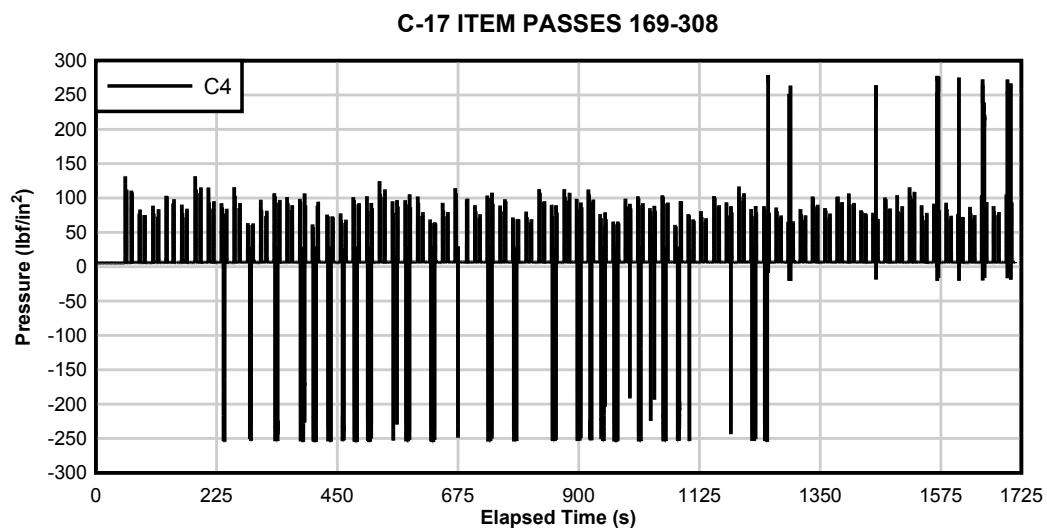
Note: C4 over-ranging. Data not usable after pass 168.

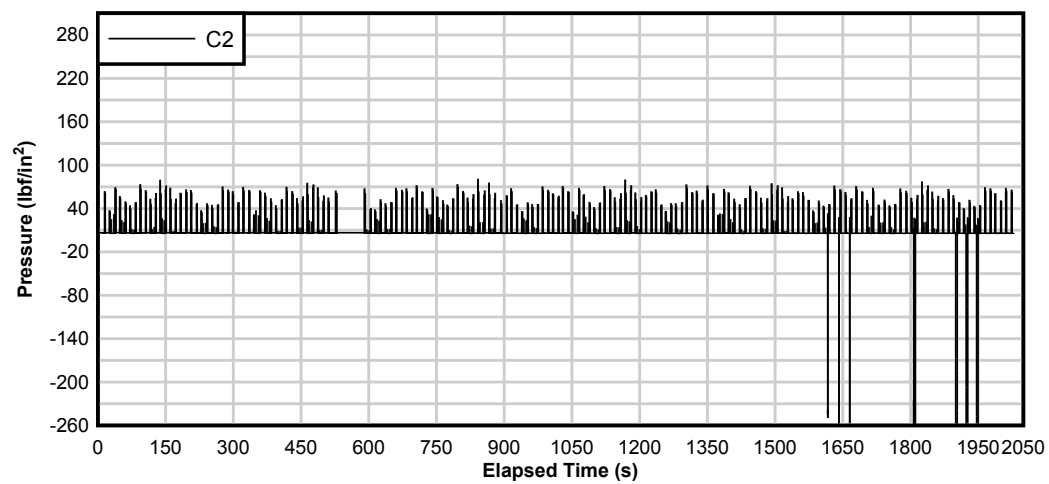
Note: C2 over-ranging during some intervals. This data was not reported

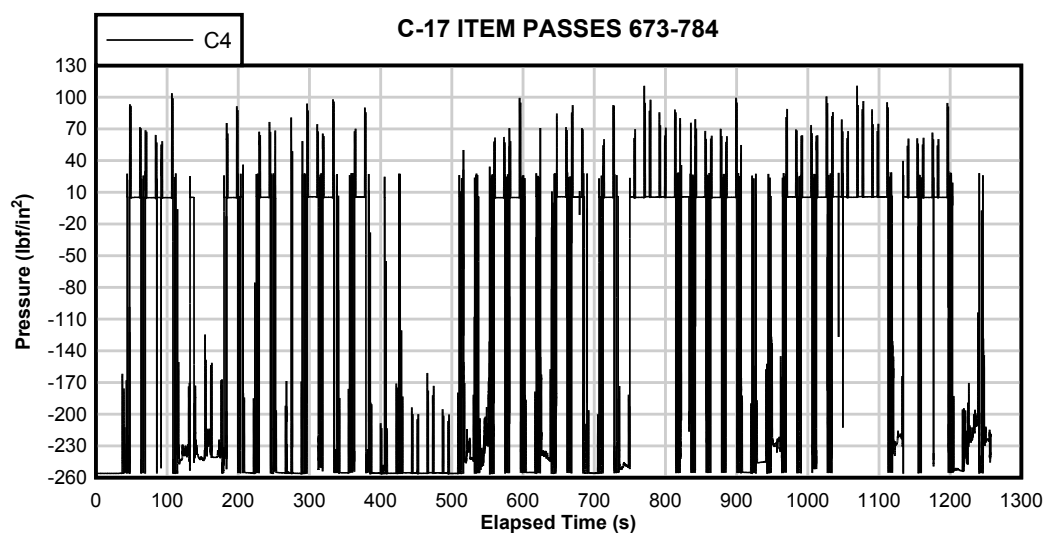
Note: Complete malfunction of C4 after pass 672.

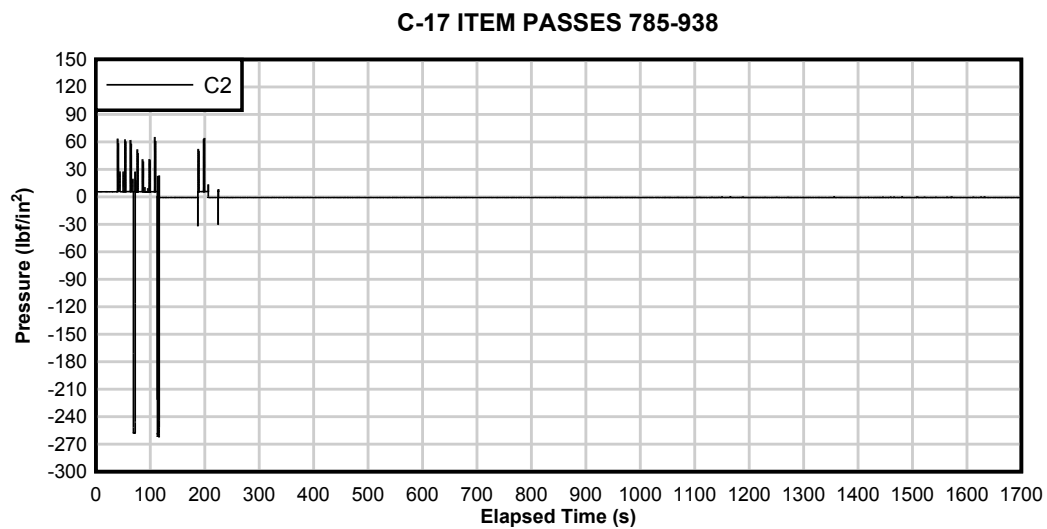
Note: Complete malfunction of C2 after pass 784

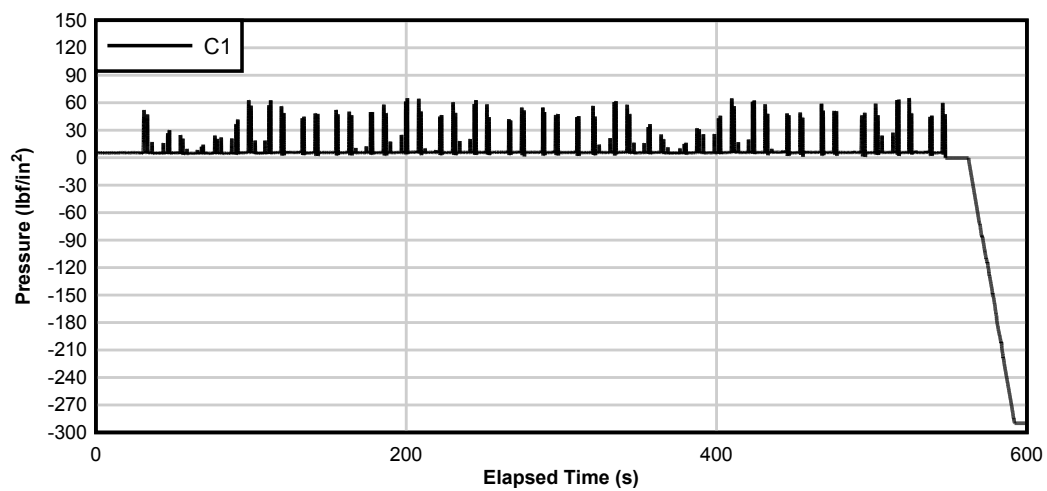
C-17 ITEM PASSES 1169-1215

Note: Complete malfunction of C1 after pass 1,215.
